# SALINITY EFFECTS ON CULTURAL HERITAGE SITES WITH FOCUS ON THE TOMB OF THE KINGS IN PAPHOS - CYPRUS

## ABSTRACT

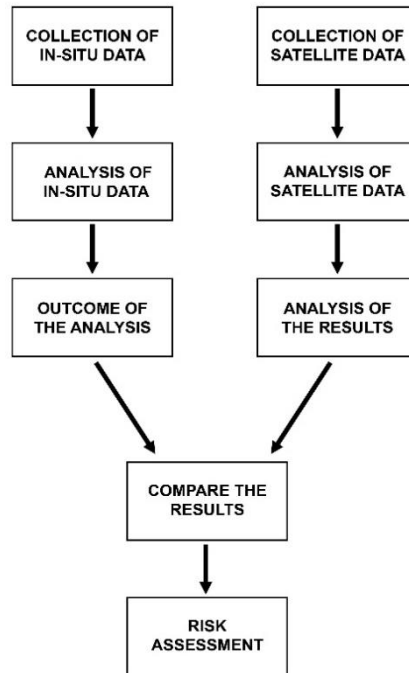
**Figure 2.** Methodology Diagram showing the process needed to reach the finalization of the risk assessment.

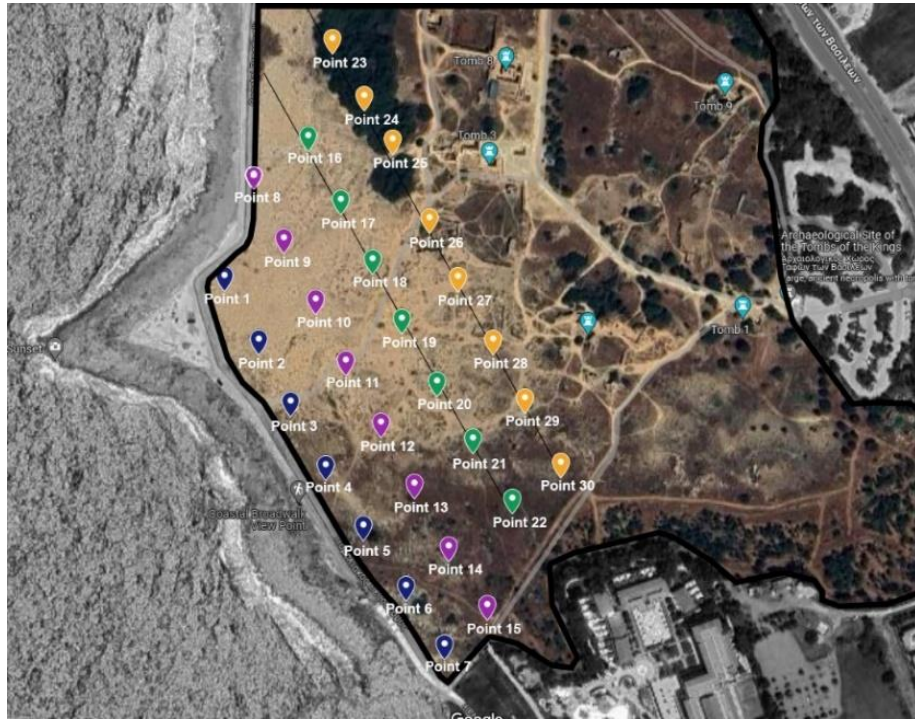
**Figure 3.** The map of the site with the creation of grid points of interest.

The first step of the methodology was data collection. Numbered gridded points were created on the map with 50 meters spacing between them. The grid was placed on the west side of the area where we assume that the site is exposed to sea salinity and covers a major part of the site as winds blow from the northwest side of the island and monuments are facing the west. This area consists of sandy ground, mainly located at the center and northwest side and low vegetated ground, located on the southern side with dense vegetation on the north side of the gridded area.

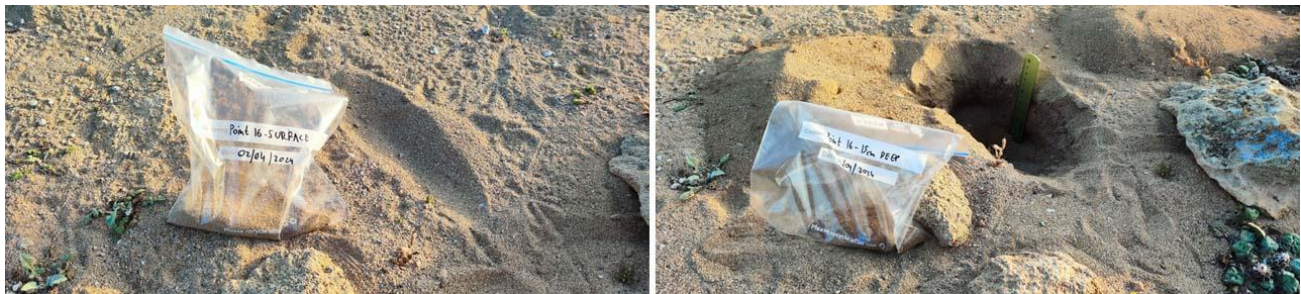
**Figure 44.** Sample collection of the point numbered 16 from the surface (left) and 15 cm depth (right)

The next step was the collection of two samples from each of the points on the selected grid area. The first sample was taken from the surface of the ground and the second sample was taken from inside the ground between 5cm and 25cm in depth. The idea was to take the samples from the same depth (around 15cm deep), although this was not always possible in the field as in some areas, the ground was hard to penetrate and collect the sample. For this reason, the depth for collecting the samples was ranged between 5cm and 25cm.

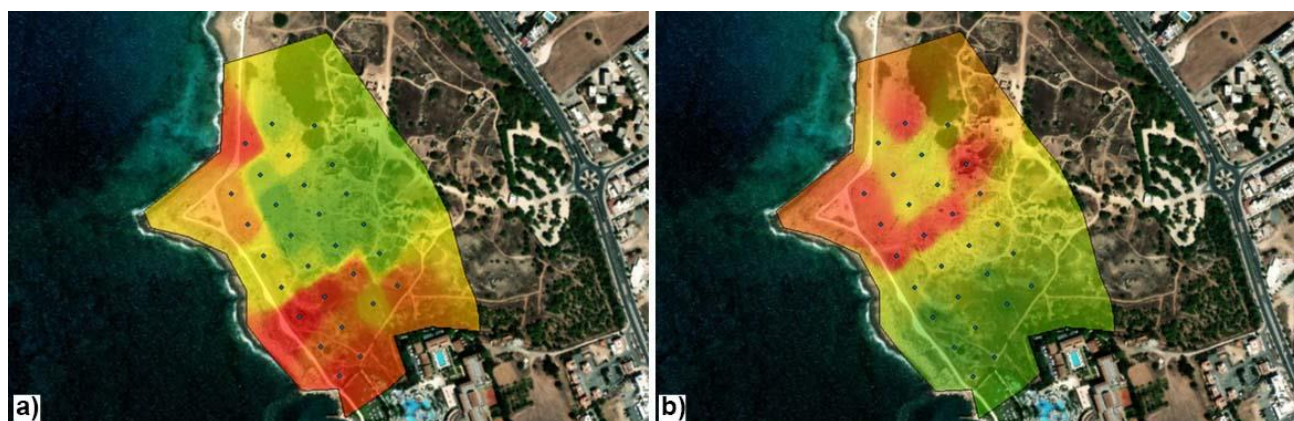
**Figure 6.** Results from the laboratory showing where lower and higher concentrations of Conductivity ( $\mu\text{S}/\text{cm}$ ) and Acidity (pH) exist. The left-side image (a) shows Conductivity ( $\mu\text{S}/\text{cm}$ ) levels. Red color indicates higher concentrations of conductivity, and green indicates less concentration of conductivity. The right-side image (b) shows Acidity (pH) levels. Red color indicates higher concentrations of acidity, and green indicates less concentration of acidity.

The results from the laboratory experiments, revealed high conductivity levels in the southern part of the area of interest, where the most vegetation exists and lower levels in the central and northern parts, where the sandy ground is located with an exception in the northwest point of the study area. On the other hand, the results showed higher acidity levels in the northern part and lower in the southern part of the area of interest.
