International Conference on Space Optics—ICSO 2006

EVALUATION AND QUALIFICATION OF COMMERCIAL OPTO-ELECTRONIC COMPONENTS FOR THE MOHA SUBSYSTEM IN ESA'S SMOS MISSION

A dedicated evaluation and qualification campaign has been performed on several optical COTS components in order to use them on ESA's SMOS mission. The evaluation phase consisted of a set of critical tests and analyses and led to the selection of the flight lot component. After selection of the components, one lot of each component has been qualified for the SMOS mission.

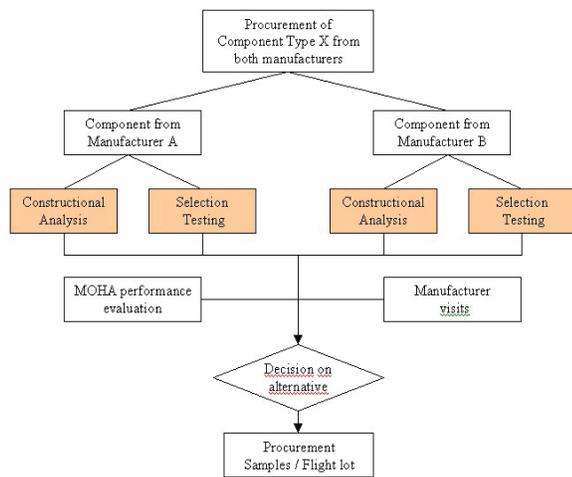
The evaluation phase was performed in order to reduce the risk of a failure during flight lot qualification with all its implications in terms of cost and schedule. Two possibilities from different manufacturers for each component were subjected to the evaluation process as depicted in Fig. 2.

Fig. 2. Evaluation flowchart

On the one hand it consisted of a set of the environmental tests (selection testing) and on the other hand of constructional analysis and manufacturer assessment. For the fibre optic parts subjected to the evaluation phase, the environmental tests considered most critical were:

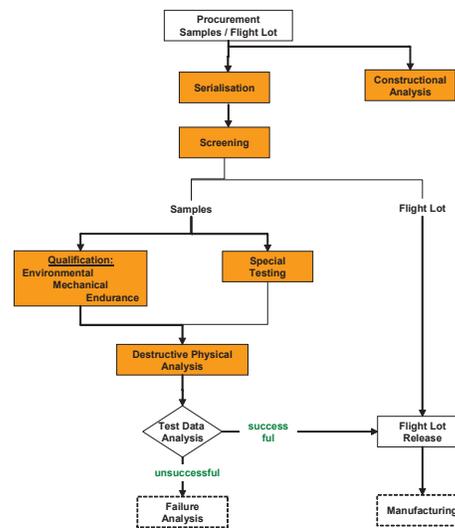
The lot procured for the flight model was then subjected to a lot and mission specific qualification campaign. The flow for this qualification is depicted in Figure 3.

Fig. 3. Qualification flowchart

For each component a dedicated test plan was established. The exact extend of the testing was agreed between all parties involved. As a general rule the test plans were made according to ESCC guidelines and comprised of burn-in /screening made on all parts and on LAT (Lot Acceptance Test) testing on sample basis. The LAT always included

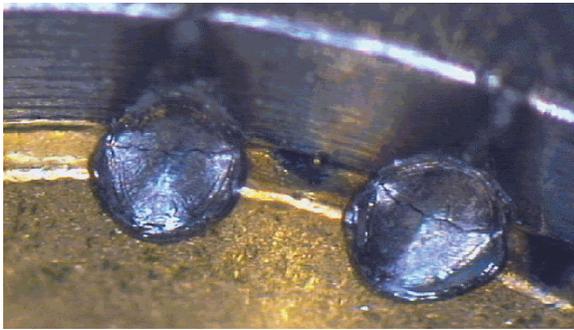
The external visual inspection performed during the construction analysis of the transmitters (ESA) showed cracks in the tack welds from the very beginning. These tack welds were used to fix the TO can inside the outer metal housing that holds the fibre pigtail assembly. Fig. 4 shows these cracks.

Fig. 4. Cracks in the tack welds

The number of tack welds per device was around 17 sometimes even higher. The shape and size of the cracks was closely monitored throughout the LAT testing and no change could be observed. Additionally, cross-sections were performed. The results of the test and the inspection of the cross-sections allowed determining that the reliability of the lasers was not reduced due to this defect. The cross section also showed that the shape of the cracks prevents the TO can from moving. The following picture shows a detail of this cross-section.

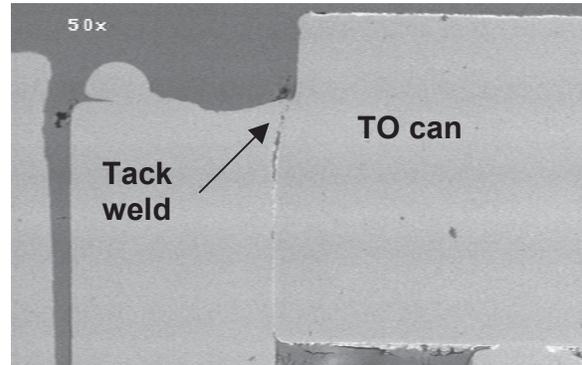
Fig. 5. Cross section of a tack weld crack.

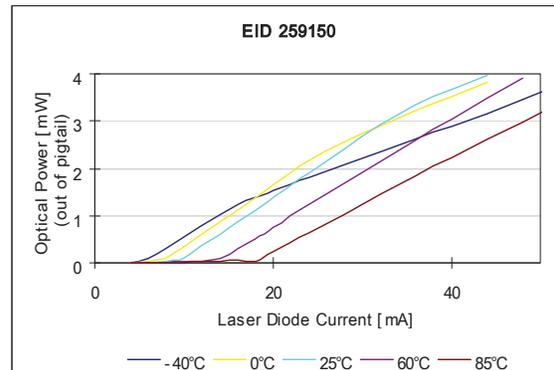
During the qualification campaign a particular behaviour at low temperature was observed: For some transmitters the slope efficiency changed at a certain power level, showing kinks in the power-current curve.

Fig. 6 Kinks in power-current curve

Discussion with the manufacturer led to the conclusion that at low temperatures a second laser mode starts oscillating and only one mode is coupled into the fibre pigtail leading to the kink in the power-current curve. This effect leads to difficulties in an automatically power controlled system since the monitor photodiode (inside the transmitter housing) would detect the multimode optical power, whereas only a single mode propagates in the fibre, leading to a tracking error of the optical power out of the fibre optic pigtail. In order to overcome this problem it was decided to screen the complete lot at minimum operating temperature and to single out transmitters with potentially high tracking error.

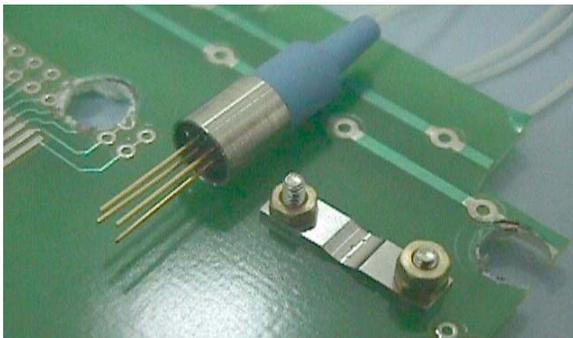
The construction analysis performed by ESA during the evaluation phase, showed weak bonding between the receiver housing and its flange. The analysis already anticipated that this could lead to a reliability problem that could be detected by vibration tests.

The results of the vibration tests during the qualification phase demonstrated this point: In random vibration test one receiver broke loose from its flange (see figure 6).

Fig. 7. Receiver vibration failure

In order to prevent these failures, epoxy was used to secure the housings to their flanges. A repetition of the vibration test with these secured components provided good results. Thus, all fibre optic receivers were to be secured in this way to comply with mission requirements.

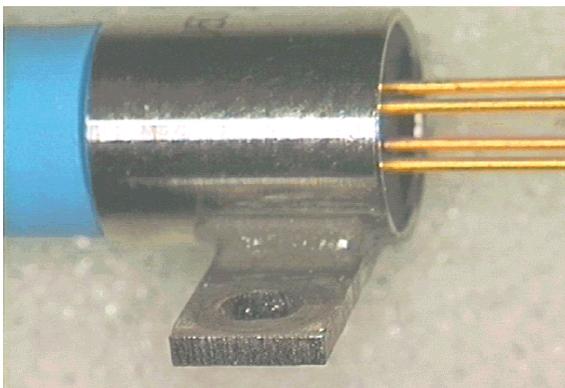
Fig. 8. Epoxy fixing the receiver metal parts.

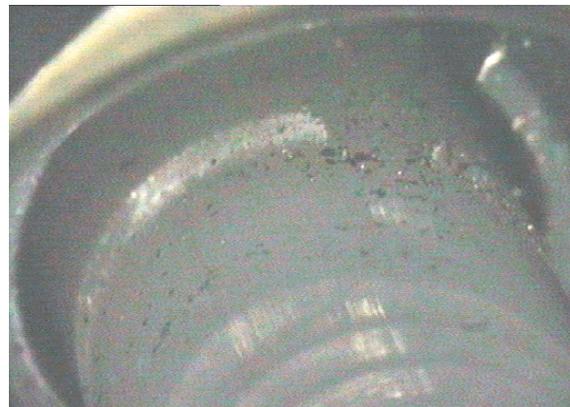
A mate-demate test of fibre optic AVIM connectors was performed during the project qualification phase. One connector was submitted to a 100 cycles of mate-demate. The attenuation of the connector was measured every 10 cycles. Cleaning was necessary every 10 cycles (with the only exception of the first 10 cycles) as debris from the metal connector was deposited in the internal part of the connector. The tighten force to screw the connector was also increased.

Fig. 9. Internal aspect of the connectors after mate-demate test.

connectorisation cycles were found to be responsible of metal debris that could influence the optical characteristics of the connections. And thus repeated inspection and cleaning of fibre optic connectors and bulkhead adapters was mandatory not only for the qualification test campaign, but throughout the manufacturing and integration steps for the MOHA subsystem (and its integration onto SMOS).

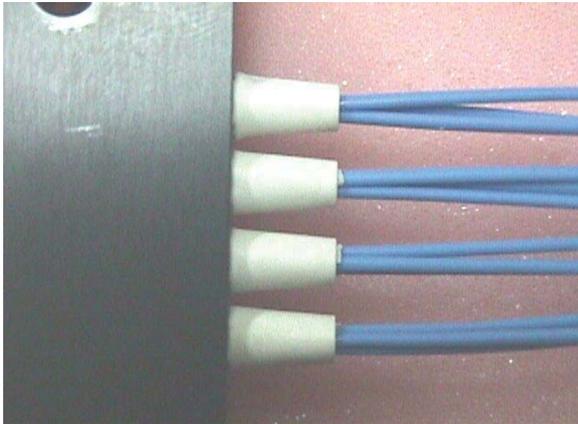
The evaluation tests of the splitters showed that the external jacket of the fibre cable shrank during thermal cycling. This led the fibre core to move into the splitter housing. This shrinkage is related to internal stresses in the cable jacket that are released at elevated temperatures and thus lead the jacket to shrink in length. Due to this effect the cable design for the cables subjected to the harshest thermal environment had to be changed and for all cables a preconditioning was introduced prior to connector assembly.

Fig. 10. Splitters output of the fibres

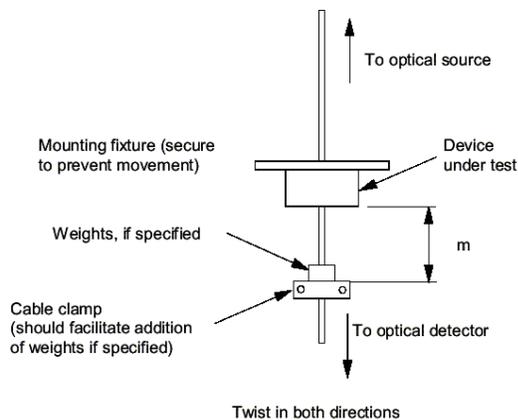
Retention tests (torsion, tension and compression tests) were performed while measuring the optical characteristics of lasers, receivers, fiber cables and fibre optic splitter assemblies. These tests were implemented by fixing the optical connectors to a system that was able to apply and measure forces by using a rotating fixing tool. As an example, the following graph shows the evolution of the attenuation of a fibre cable assembly while tension and torsion were applied. All samples passed the tests.

Fig. 11. Set schematic for cable retention test.(fibre cable assembly)

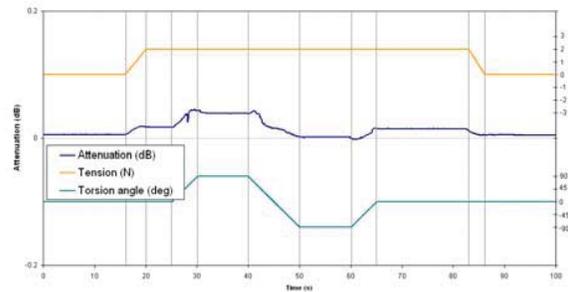
Fig. 12. Attenuation evolution during torsion and tension test (fibre cable assembly)

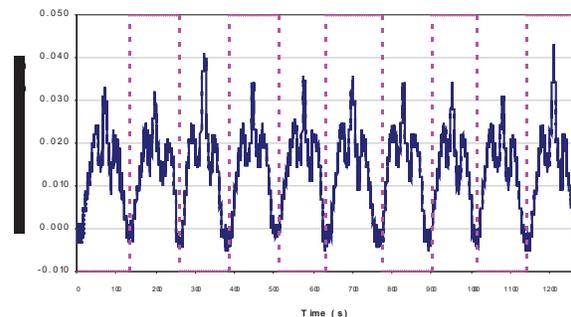
A cold bend test was implemented for checking the behaviour of an optical fibre while it was bended under space conditions. The test was performed at -60°C using a climatic chamber with a hole. A system with a chain was used to rotate the cylinder where the fibre was placed. The test included ten cycles of bending of a complete turn of the fibre in both directions. Humidity was reduced in two steps. The climatic chamber reduced the humidity while the temperature was over zero degrees. Nitrogen atmosphere was used all the time. The following graph shows an example of the obtained results.

Fig. 13. Evolution of the attenuation of a fibre during cold bend test.

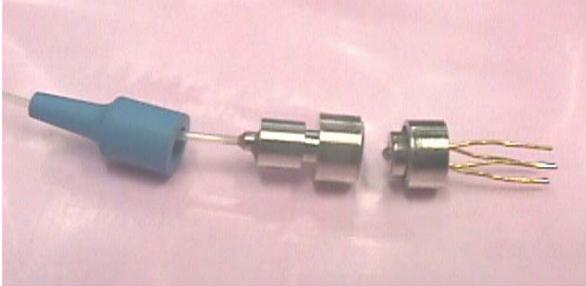
A receiver failed after mechanical shock tests. The responsivity decreased to less than 20% of the original value. After several inspections, the failure was found to be related to the presence of a particle located at the end of the fibre placed in the photodiode. A picture of the particle was taken and an EDX material analysis was performed before removing it by means of mechanical methods. The electro-optical measurements after removing the particle demonstrated that the particle was the cause of the failure. The origin of the particle seems to be related to the two polishing planes

Fig. 14. Receiver opened.

of the end of the fibre that leave a hole that connects the cavity in the photodiode to the lateral of the fibre. The following pictures show the receiver opened and the particle located exactly at the centre of the fibre. After removal of the particle the receiver was operating normally.

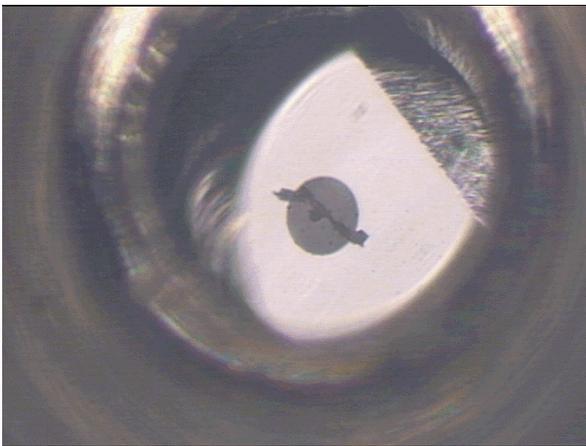
Fig. 15 Particle found on the end of the fibre after opening the receiver.
