# Silica laser damage mechanisms, precursors and their mitigation

J. Bude, P.E. Miller, N. Shen, T. Suratwala, T. Laurence, W. Steele, S. Baxamusa, L. Wong, W. Carr, D. Cross, M. Monticelli, M. Feit, G. Guss

Lawrence Livermore National Laboratory  
7000 East Avenue, L-460, Livermore, CA 94550 USA

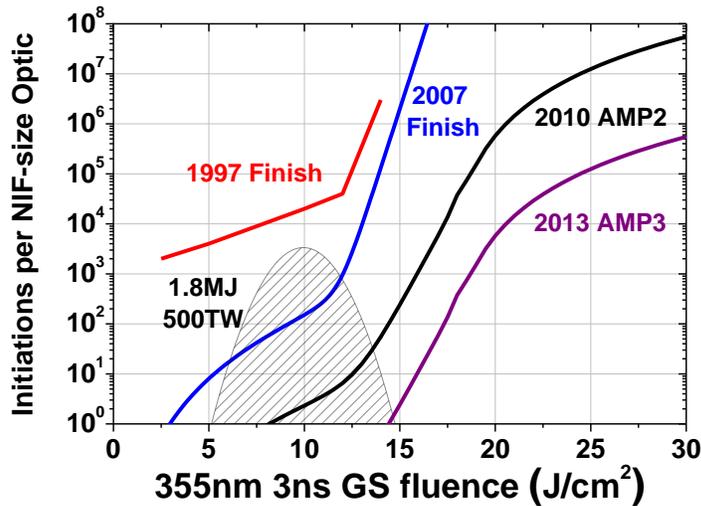
Figure 1: NIF silica optic surface damage density improvement from 1997 to the present: damage initiations per NIF-sized optic (1100cm<sup>2</sup>) at 355nm with 3ns Gaussian (GS) pulses. A fluence histogram for a typical ICF shot [2] is shown along with the damage density

Figure 1 shows a plot of the improvement of silica surface damage initiation density for NIF optics ( $1100\text{cm}^2$ ) as a function of 355nm fluence with 3ns Gaussian pulses from the late 1990's to the present. Each generation has seen a reduction in the overall damage density,  $\rho(\phi)$ , and an increase in damage threshold as defined by the fluence onset of measureable damage (one site per optic). The damage density for these optics has been plotted together with a fluence histogram for a typical 1.8MJ 500TW ICF-type ignition pulse [2]. Optics produced in 1997 would have been expected to have tens of thousands of damage initiations for these shots. By 2007 improvements in finishing quality [5] reduced the number of damage initiations to hundreds of sites, and as seen in the plot, significant improvements have continued to the present day.. This paper discusses research advances which have driven these improvements. in particular, an understanding of silica damage mechanisms and the properties of damage precursors (the absorbers which lead to optical damage), an identification of the most important damage precursors in a given fluence range, and the means to reduce or eliminate these precursors (mitigation). This work has led to the Advanced Mitigation Processes (AMP) shown in Figure 1, referred to as the AMP2 [6] and AMP3 [7] generations of AMP, which push damage densities toward zero for reasonable fluence ranges (below  $45\text{J}/\text{cm}^2$ ).

Damage precursors strongly absorb sub band-gap light, effectively transfer that energy to the silica glass matrix, and can be sub-100nm in size. In this section we will address the damage precursors which contribute to the damage shown in Figure 1 below 10J/cm<sup>2</sup> and which were responsible for many hundreds of damage sites for the optics such as those from circa 2007 when exposed to a 1.8MJ ICF laser shot (see Fig. 1). Here, we look at precursors on silica surfaces free of particulates and gross contamination. Such sources of contamination are known to damage optics in general [17], and can be mitigated using standard cleanliness protocols prior to use in a laser system; contamination during laser operation

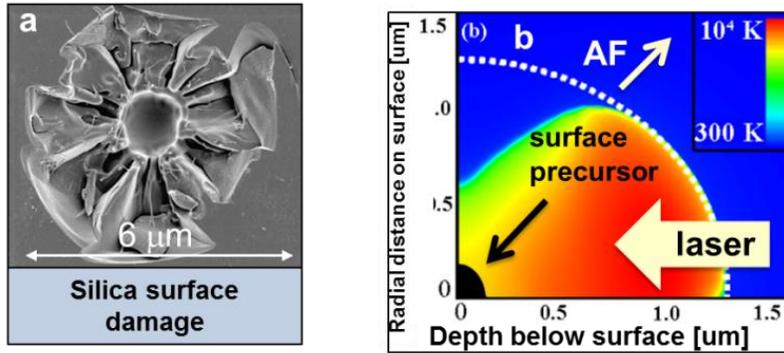
Figure 2: (a) Laser initiated silica surface damage site. Sites such as these with fracture networks grow upon future exposure to laser light and limit an optics lifetime. (b) Hydro-dynamic simulation of laser supported absorption front (AF) formation from a surface nano-scale damage precursor (see [12]).

Figure 2a shows a typical silica surface damage site upon initiation with a single laser pulse. Sites can initiate with sizes from 5um to 30um depending on the pulse shape, but all sites which subsequently grow have a molten central region surrounded by a fracture network suggestive of explosive ejection of material from below the surface. Often these micron-scale damage sites are generated from absorbers too small to see optically – nano-scale absorbers. Hence, surface damage requires that an absorbing defect couple laser energy into the near-surface bulk glass. One model which describes this process well is the absorption-front (AF) model [12]. The process begins when a near surface precursor is heated by the absorption of laser light (sub band-gap with respect to the bulk). When the material around this precursor reaches a sufficient temperature, the bulk (intrinsic) glass begins to absorb light through temperature-activated intrinsic absorption with an absorption coefficient  $\alpha_{INT}(T)$ . Intrinsic absorption leads to a thermal run-away driving the glass temperature as high as 10,000K as more laser energy is coupled into the heated glass. This process can continue until the end of the laser pulse. *The coupling of thermal conduction with T-activated absorption provides the mechanism by which this energy spreads into the bulk back towards the laser with a nearly constant velocity – a laser-supported absorption front.* AF propagation velocities are much higher than energy transport via diffusion alone could provide. This behavior is driven by temperature activated absorption plus thermal conduction by both phonons and thermally activated free

carriers. In fact, thermally activated thermal conduction by free carriers is necessary to describe the observed behavior [12]. Figure 2b shows a hydrodynamic simulation of an absorption front propagating away from an absorbing precursor back towards the laser source. The AF leaves a region of super-heated material microns below and around the original absorber, and explosive ejection of this material leads to the molten core and fracture region seen in Figure 2a.

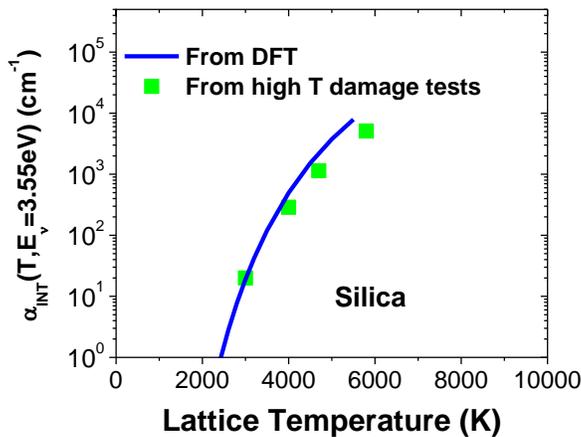
Figure 3: Intrinsic absorption coefficient in silica,  $\alpha_{INT}$ , at 355nm as a function of temperature as estimated from high temperature damage threshold measurements and computed by ab-initio DFT simulations.

**Precursor absorptivity:** An essential feature of this model is the demonstration of temperature activated intrinsic absorption. Direct measurements of the temperature dependence of optical absorption are limited to temperatures below the melting point and to high energy photons near the band-edge of silica [13]. We have used indirect methods to estimate T-activated absorption at 355nm (far below the band-edge) and to demonstrate the role of temperature activated absorption in surface damage. Such experiments use a pulsed mid-IR laser (10.6μm) to heat the silica surface to temperatures well above the melting point, and a 355nm ns laser is focused through the heated region and triggered at the end of the heating pulse (see for example [14]). The interaction of the 355nm pulsed laser with the heated glass leads to material removal and damage consistent with temperature activated absorption -- damage happens at lower fluences on surfaces that have been heated. The fluence dependence of the damage combined with in-situ temperature diagnostics and simulations of thermal run-away yield estimates for  $\alpha_{INT}(T)$  shown by the symbols in Figure 3.

We also performed time dependent ab-initio density functional theory (DFT) simulations to estimate  $\alpha_{INT}(T)$  [14]. These simulations agree well with the direct measurements of absorptivity performed at lower temperatures [13] and provide values at 355nm (3.5eV) for the temperature range shown in Figure 3. Simulated results are plotted together with the

high temperature damage data in Figure 3 showing excellent agreement. Analysis of the DFT simulations indicate that temperature-activated absorption in silica is due to the Urbach broadening of the band edge, band-gap narrowing and at 10,000K, band-gap collapse. These processes are the result of thermal-induced disorder of the atomic structure of silica at high temperatures which creates band-tail states and a reduction of the band-gap. Based on these values for  $\alpha_{INT}(T)$ , thermal run-away will occur when the temperature of a suitable precursor reaches 3,000 to 4,000K. Therefore damage precursors must absorb enough light to during the laser pulse to reach these temperatures. Hence, in silica, thermal run-away and AF formation is not related to phase transformations such as heating to the melting point of the material, but is driven by Urbach processes. This typically requires that the precursor have an absorptivity of greater than  $10^4 \text{ cm}^{-1}$  depending on precursor size. Energy transport models were developed to include these effects. The model has been validated for both model systems [16] and in surface damage experiments [12].

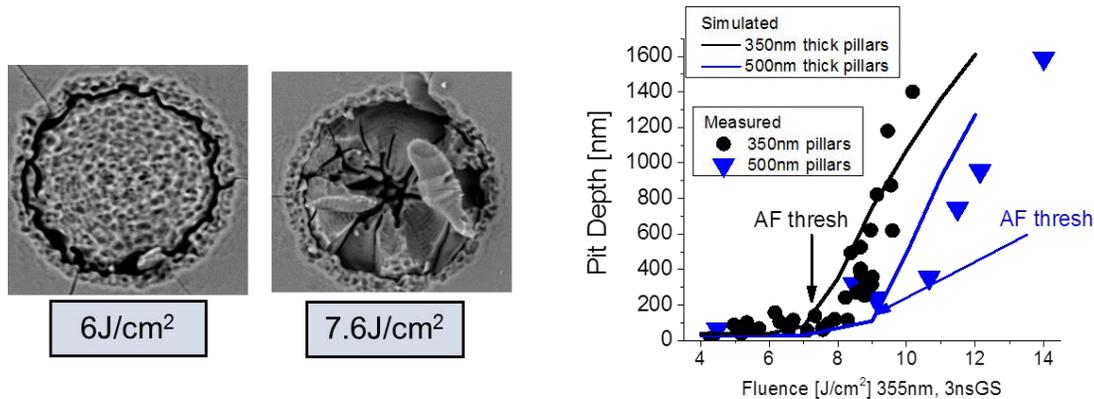
Figure 4: Experimental demonstration of AF formation and damage in silica [16]. Figure 4a (left): micrographs of Al pillars on silica surfaces after exposure to 355nm laser pulses – 6J/cm<sup>2</sup>, below AF threshold, 7.6J/cm<sup>2</sup>, above AF threshold, damage site with fracture. Figure 4b (right): simulated and measured pit depths created by AFs showing threshold conditions (temperature) for absorption front formation.

**Surface adhesion and thermal coupling:** The experimental demonstration on model systems highlighted another important property of surface damage precursors – surface adhesion. In these experiments, Al pillars were patterned on a silica surface, furnace annealed at temperatures between 500°C and 600°C, and exposed to laser light [16]. Given the known absorptivity of Al, a simple 1D heat transport model was used to compute the Al temperature as a function of laser fluence. This work showed a clear threshold above which fractured damage sites were formed and below which the Al was removed without substrate damage (Figure 4a). Simulations showed that this threshold corresponds to the onset of thermal run-away via the AF model (Figure 4b). The higher the fluence, the deeper the AF penetrated and the deeper the resulting damage pit (and the greater the fracture). The furnace anneal was necessary to ensure sufficient adhesion to the surface. Without it, the Al films escape from the surface before enough heat flows into the substrate to initiate an AF. Although the un-annealed Al films became very hot (many thousands of K), the substrate sees only modest (100nm) surface perturbation. Hence a damage precursor may be nano-scale, but it must absorb enough light to launch an AF and it must be strongly (chemically and vibronically) bonded to the surface or in fact, to be defects in the silica itself. Adhesion to the surface and thermal coupling is important for particle and contaminant-related damage as well.

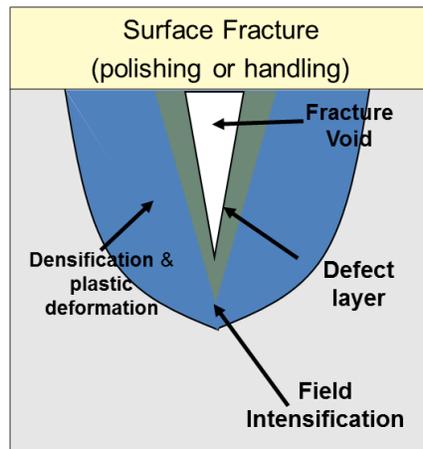
Figure 5: Potential damage precursors associated with surface flaws created by polishing and handling.

The processes involved in material removal during polishing introduce mechanical and chemical modifications to the silica surface which may be associated with laser damage. These include contamination from residual polishing compounds (typically Ce or Fe in MRF systems), structural densification of the glass, plastic deformation and fracture. Ce and Fe contamination will result in laser damage, but can be removed by acid leaching or weak etching chemistry [18]. However, structural flaws and the precursors primarily responsible for damage below  $10\text{J}/\text{cm}^2$  remain. To address these precursors and propose mitigation strategies, we performed a controlled indentation study to understand what aspect of a flaw leads to laser damage. Various candidates include optical field intensification due to fractures, impurities trapped in fractures and defects associated with plastic deformation, structural densification or the fracture itself (Figure 5). Here, we briefly describe results from this study (see [19] for complete details).

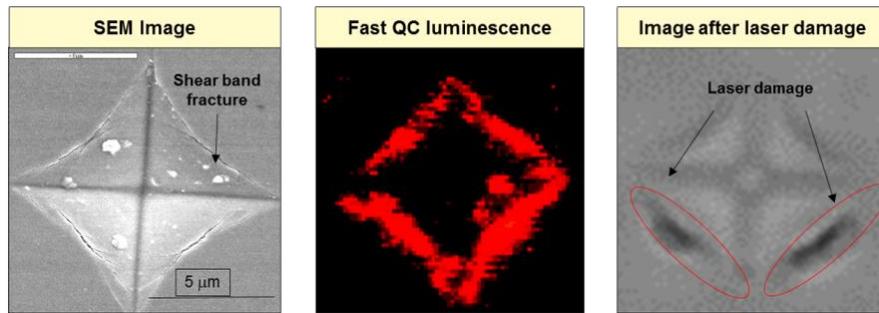
### 0.5N Vicker's Indentations

Figure 6: Low load 0.5N indent on silica surface: SEM image showing 20nm wide surface fractures; QC PL surface image showing correlation of highly absorbing species with fine fractures; microscope image after laser exposure showing correlation between damage, PL and fracture [19].

This study used static indentation to produce, in a controlled way, structural modifications associated with finishing. A variety of micro-indenters were used including diamond shaped Vickers, and Knoop indenters as well as a ball-type (blunt) Brinell's indenter. Various loads were applied, and the resulting surface perturbations were studied with a variety of techniques including optical, and secondary electron microscopy, time-resolved confocal photoluminescence imaging [20] and laser damage testing. Figure 6 shows a 0.5N Vickers indentation on a silica surface. At this load, the material beneath the indent is densified, but no noticeable fracture is visible optically. Photoluminescence images (Figure 6b) show a strongly photo-active species lining the periphery of the indent. The photoluminescence was broadband and exhibited a broad continuum of lifetimes down into the pico-second regime. This type of quasi-continuum (QC) photoluminescence is associated with a high density of interacting defects [20] and has been correlated to laser damage. From the discussion above, it is clear that laser damage precursors must have a very high absorptivity ( $> 10^4 \text{ cm}^{-1}$  at 355nm) in order to reach temperatures sufficient to result in thermal run-away and AF formation; it is expected that the high density of interacting defects associated with QC photoluminescence could provide such a strong absorption.

Identification of fracture surfaces as damage precursors suggests an etch-based mitigation. We used an HF acid-based etch to open surface fractures and remove the absorbing defect layer [6]. A shallow etch (100nm) of the 0.5N indent in Figure 6 completely removed the PL and increased the damage threshold to a value consistent with that observed on a fracture free portion of the surface [19]. Longer etches were needed to fully etch deeper fractures. Initial studies for deep fracture etching actually decreased the laser damage threshold. Examination of these deeper etches revealed the presence of etch-product precipitates; such precipitates were found to be photo-active as observed by PL imaging and easily damaged upon laser exposure. It is likely that earlier attempts to increase silica damage thresholds by oxide etches were affected by these etch products; in fact, etch products can actually reduce the surface damage threshold.

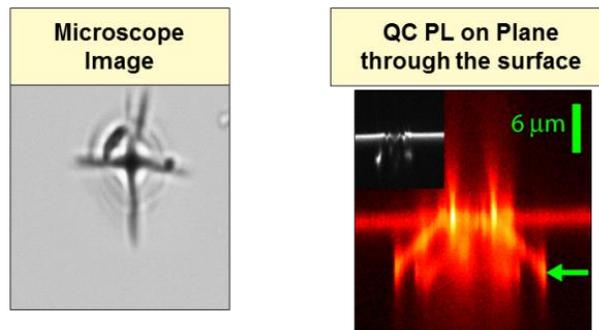
### 10N Vicker's Indentations

Figure 7: High load 10N Vicker's indent with extensive fracture: microscope image and confocal time-resolved QC PL image through the fracture showing photo-active species on the fracture surfaces [19].

Initially it was unclear what structural feature was associated with this ring of photoluminescence. The densified material exists throughout the entire area of the indent, but the QC PL was found only on the edge. We would expect that the material at the edge was modified by plastic deformation, but separate experiments in [19] ruled this out as well. Careful examination of this indent with SEM showed very fine fractures ( $< 20\text{nm}$ ) on the periphery of each indentation. . These subtle fractures were correlated with the PL and hence were strongly photo-active. Laser damage testing confirmed that damage occurred first on these fracture cusps as well. Studies of larger indents such as the 10N Vicker's indent in Figure 7 clearly show that these damage precursors are confined to within 500nm of the fracture surface (see for example, the confocal PL image of a cross sectional plane through the surface of the 10N indent in Figure 7B).

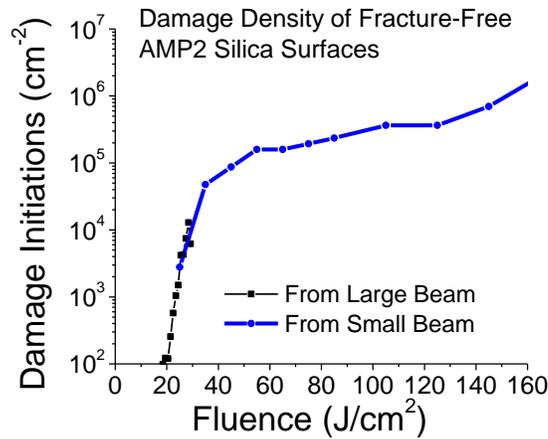
Figure 8: Damage density measured on an AMP2 surface as a function of 355nm fluence out to  $160\text{J}/\text{cm}^2$ . Measurements are a compilation of large beam damage tests at lower fluences and small beam S/1 tests performed as per [10].

While the AMP2 process fully mitigates fracture-related damage and significantly reduces damage density for fluences below  $10\text{J}/\text{cm}^2$ , there remain classes of precursors which lead to a sharp rise in damage initiations above  $10\text{J}/\text{cm}^2$ . These "high fluence" precursors are not associated with any readily observable feature on the surface (such as surface flaws or roughness) and are too subtle to be detected by photo-luminescence or photo-thermal imaging. This threshold-like behavior is seen in many materials and sometimes suggests an intrinsic damage threshold associated with intrinsic material or surface property. However, measurements of the damage density out to  $160\text{J}/\text{cm}^2$  suggest an extrinsic mechanism with most of the damage precursors lying below  $40\text{J}/\text{cm}^2$  for 3ns Gaussian pulses [10] (see Figure 8). Above about  $40\text{J}/\text{cm}^2$  the damage density becomes fairly flat indicating a nearly constant precursor density. In fact, small beam damage tests demonstrate that there are significant fractions of the surface that are free of damage precursors when exposed to fluences of to  $160\text{J}/\text{cm}^2$  (see Figure 8).

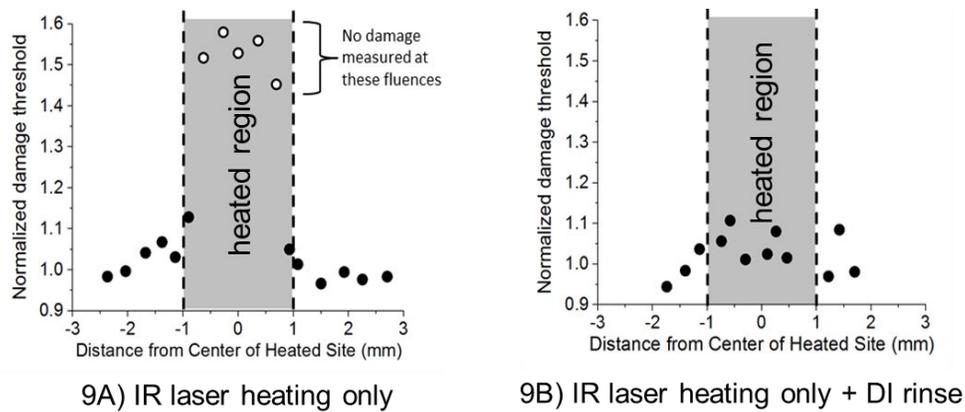
Figure 9: Damage thresholds measured as a line-out through 2mm regions of an AMP2 silica surface heating by a CO<sub>2</sub> laser to temperatures greater than 2,000K. Figure 9A (left): S/1 thresholds measured after CO<sub>2</sub> laser heating. Figure 9B (right): S/1 thresholds measured after DI water rinse of samples in 9A [7].

To this end, we created a series of mid-IR laser heated sites on a set of AMP2 silica substrates. R/1 damage thresholds were measured on controls for each sample to ensure efficacy of the heat treatment. Then, samples were passed through the various steps in the AMP2 process working backwards from the last step to the first; steps tested included surface drag wiping, a de-ionized (DI) water spray rinse, an ultra-sonic DI water rinse bath, and mega-sonic BOE etching. The strategy was to see whether any of these steps re-introduced high fluence precursors. In fact, the results demonstrated that all of the wet processing steps did. Figure 9B shows results of a heat-treated site like that in Figure 9A after a DI spray rinse. The damage threshold of the entire site returned to values near that of the rest of the surface, *so that reprocessing, even with DI water, leaves damage precursors linked to high fluence damage* [7]. These results implicate either water-silica surface chemistry or trace contaminants carried in the water.

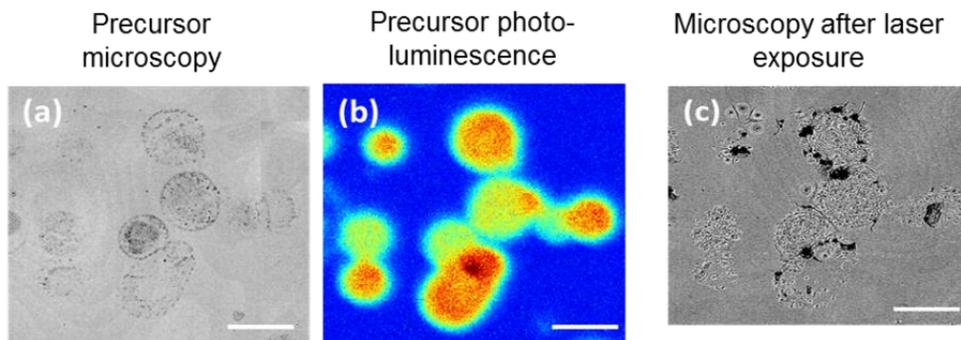
Figure 10: Demonstration that precipitates of NaCl salts on silica surfaces are laser damage precursors at 355nm [7].

Even 18M $\Omega$ -cm deionized water often has part per billion quantities of dissolved ionic impurities; the most common are simple sodium ( $\text{Na}^+$ ), calcium ( $\text{Ca}^{2+}$ ) or potassium ( $\text{K}^+$ ) based salts. If such salts form high fluence precursors, their precipitates should be nano-scale (hence invisible to optical microscopy); and, based on the discussion in Section 2, they must absorb strongly in the UV (reaching thermal run-away during the laser pulse), and they should be bonded firmly to the surface. As impurity loads in our processing liquids are very low and precursor densities are high -- more than  $10^5 \text{ cm}^{-2}$  (see Figure 8) -- it is reasonable to expect that precipitates would be small, possibly nano-scale. It is also likely that impurities deposited during drying on silica surfaces would be reasonably adherent (compared to, for instance, contaminants introduced onto a dry optic). It was, however, unclear whether precipitated salts could absorb sufficient UV light to initiate laser damage. To test whether precipitates of common salts could initiate damage, we prepared a solution of NaCl and applied it to silica surfaces as aerosolized mist. Because the NaCl concentration was high, the precipitates which formed were large (many microns) and were readily visible by optical microscopy (Figure 10a). Photoluminescence images clearly demonstrated that such precipitated salts were photo-active (10b). Laser damage testing revealed that such precipitates did initiate laser damage (10c). In fact, R/1 tests of a variety of common salts and the organic solute sucrose all led to laser damage as seen in Figure 11. Here, the control is the uncontaminated AMP2 silica surface. Figure 11 also shows the bulk band-gap of these salts, all of which are much higher than the photon energy of 3.55eV (355nm), so that the optical absorption in the bulk of these materials cannot lead to damage. Therefore, the absorption which leads to laser damage likely occurs on defective surfaces in some way similar to the fracture defect layers. *Many precipitates absorb enough energy to be laser damage precursors, even if the bulk material is nominally transparent. The optical absorption which leads to damage must occur on defects associated with heterogeneous precipitation on silica surfaces.*

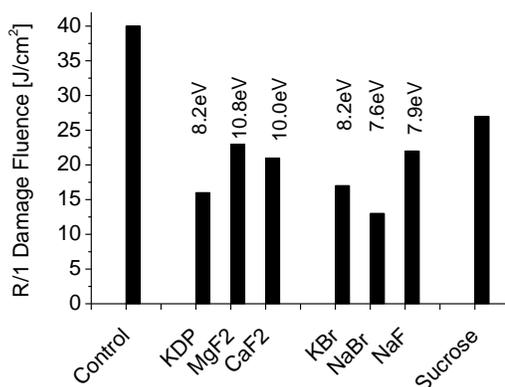
Figure 11: R/1 laser damage thresholds for materials precipitated on silica surfaces – this demonstrates that precipitates of common salts and the organic solute sucrose can be surface damage precursors. The control sample corresponds to the uncontaminated silica surface. The band-gap energies for the bulk materials show that they are nominally transparent to 355nm light.

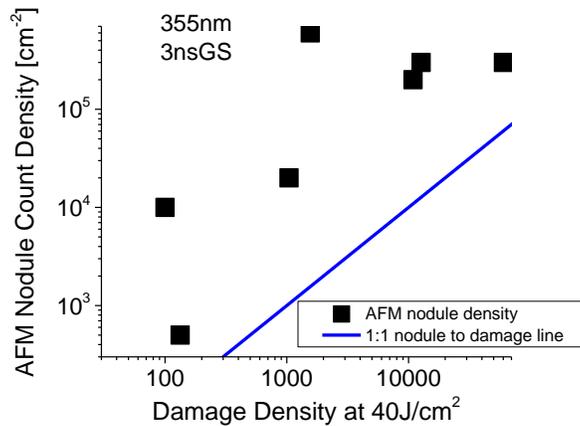
Figure 12: Correlation between AFM nodule counts and damage density at 40J/cm<sup>2</sup> for a survey of AMP processed samples [7].

A survey of these samples clearly showed a correlation between nano-scale precipitates as measured by atomic force microscopy (AFM) and laser damage. AFM studies of these samples revealed that after drying, nodule-like features appear on this otherwise smooth surface; they have typical dimensions less than 100nm in the plane and tens of nm high. Figure 12 plots the AFM nodule count density versus the damage density computed from laser damage tests using a 1cm<sup>2</sup>, 5ns FIT (3ns GS), 355nm laser beam. Damage density is plotted in cm<sup>-2</sup> at 40J/cm<sup>2</sup>. A correlation is shown in which the nodule density tracks the damage density. Note that nodule density is always somewhat higher than damage density as it should be -- some of these nodules probably don't damage at test fluences. We interpret these nodules as process-related precipitates which are visible when surfaces are clean and smooth enough to get good AFM data.

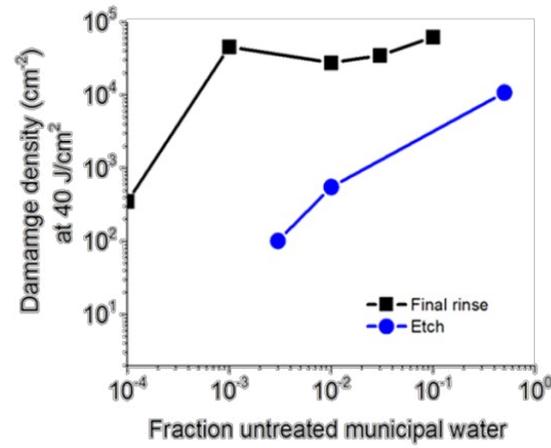
Figure 13: Plot of damage density at  $40\text{J}/\text{cm}^2$  as a function of untreated processing water introduced in both the etch step and the final optic rinse [7].

We estimated the impact of various impurity concentration on damage performance for different parts of the AMP process. One such result is shown in Figure 13. We designed this study to look at the effects of DI water purity on damage density measured as above at 40J/cm<sup>2</sup> in order to prove that the impurities *found in our DI water* would produce high fluence precursors. To this end, we started with 18MOhm-cm DI water (the measurement limit of ionic impurities set by the auto-disassociation of water), and doped such solution with untreated municipal water; the resulting mixture then mimics varying levels of de-ionization of the input water stream. Two experiments are shown: one in which the contaminated water was introduced in the AMP2 etch bath, and one in which it was introduced into the final DI water spray rinse. All other parts of the process were left un-touched. The result shows that impure DI water in either source increases damage density, but that the effect is much stronger when the impure water is introduced into the final rinse. It is likely that impurities in the etch bath near the beginning of the process are in some part removed during subsequent processing, whereas impurities in the final rinse will necessarily dry on the optic's surface. Experiments like this lead to the conclusion that *high fluence damage increases strongly when processing impurity concentrations exceed 10ppb [AMP3 ref]*.

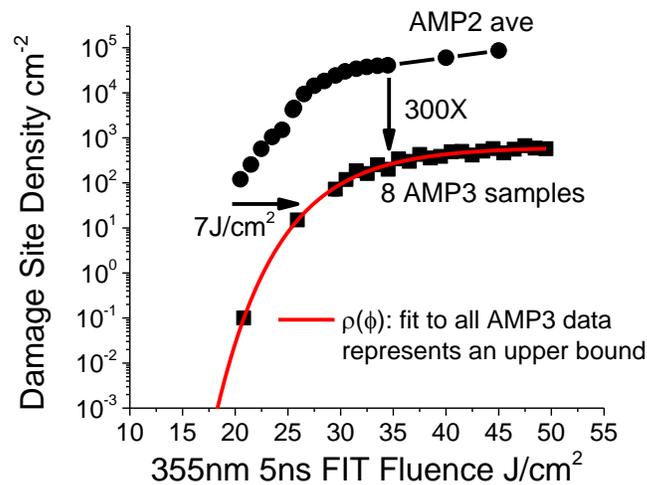
Figure 14: comparison of damage density between AMP2 and the AMP3 process optimized to reduce the probability of precipitation from wet chemical processes: shows a 300X reduction in overall damage density and a  $7\text{J}/\text{cm}^2$  shift to higher fluences [7].

The AMP protocols developed here comprise the AMP3 process as shown in Figure 14. The damage density for AMP2 and AMP3 was measured using large beam damage tests in OSL. For fluences above about  $30\text{J}/\text{cm}^2$ , tests were performed with a  $1\text{cm}^2$  beam; multiple samples were averaged. In order to accurately measure the low AMP3 damage density below  $30\text{J}/\text{cm}^2$ , we also performed tests with an average fluence of  $23\text{J}/\text{cm}^2$  (with tails up to  $32\text{J}/\text{cm}^2$ ), and at an average fluence of  $15\text{J}/\text{cm}^2$  (with tails up to  $25\text{J}/\text{cm}^2$ ) over about  $32\text{cm}^2$  of tested area. The test at  $23\text{J}/\text{cm}^2$  yielded one damage site, and the test at  $15\text{J}/\text{cm}^2$  yielded no sites over  $32\text{cm}^2$ . The curve shown in Figure 14 is a best fit to all three of these measurements. Process modifications responsible for AMP3 reduced the damage density at high fluence ( $30\text{J}/\text{cm}^2$ ) by a factor of 300 compared to the AMP2 process and shifted the entire curve towards higher fluences by  $\approx 7\text{J}/\text{cm}^2$ . The AMP3 process is stable, consistently producing results like those shown here. This improvement would enable a 70% increase in silica optic operating fluence and a dramatic reduction in damage initiations at current operating points. More recent results [B] allow one to extend these improvements to 2000X reductions in damage density with a nearly  $10\text{J}/\text{cm}^2$  shift to higher fluence.
